INDOOR AIR QUALITY ASSESSMENT

**Massachusetts Department of Revenue
Child Support Enforcement Division
Route 6A
Barnstable, Massachusetts**

Prepared by:
Massachusetts Department of Public Health
Bureau of Environmental Health Assessment
December, 2000

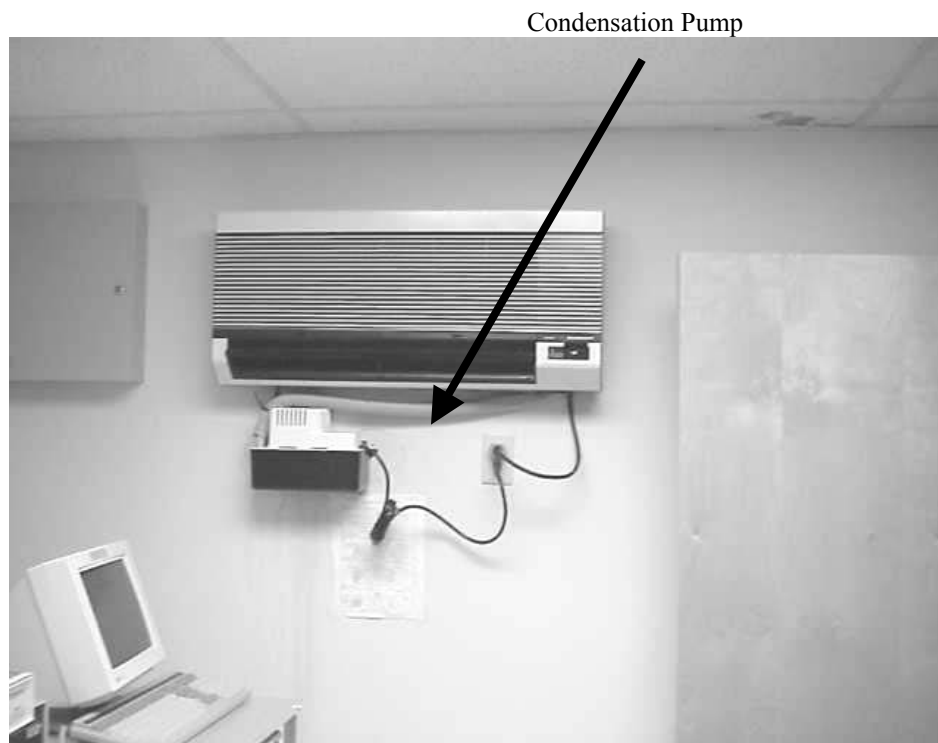
Picture 1

The mainframe room contains an air conditioning unit (see Picture 1). A pipe system is installed in this unit to drain moisture generated by the cooling coil of this unit. A condensation pump is used to impel condensation into the drain. Wallboard around the condensation pump appears to have been repeatedly wet, resulting in possible mold growth (see Picture 2). In addition, this area also had a water-damaged ceiling tile. If repeatedly moistened, ceiling tiles and wallboard can serve as a medium for mold growth.

Mainframe Room Air Conditioning Unit

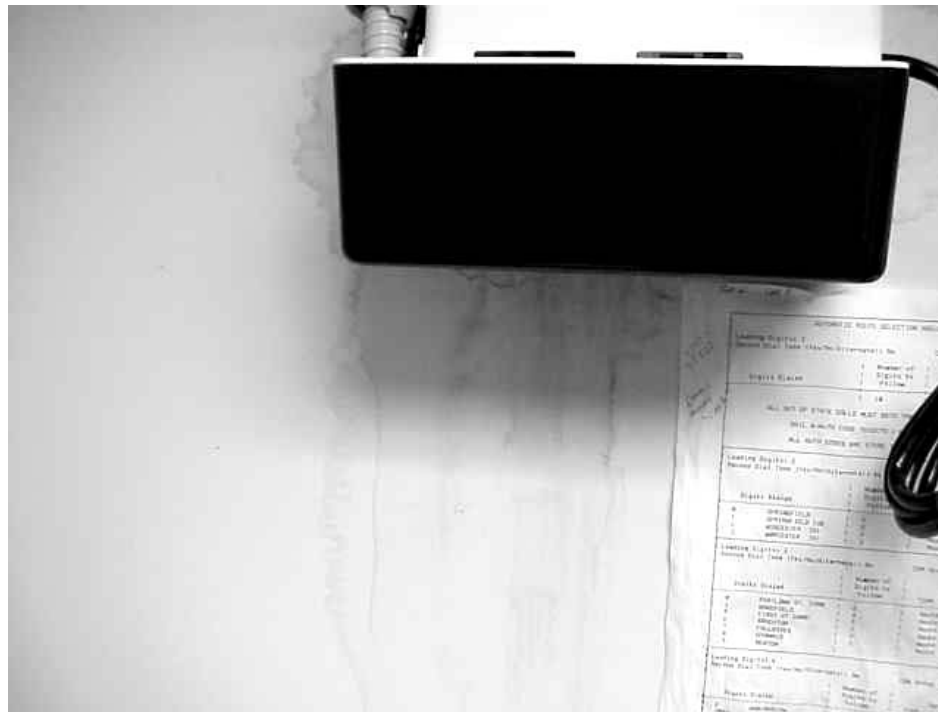
Picture 2

Water Damaged Wallboard below Condensation Pump in Mainframe Room

4. Replace water damaged wallboard around the condensation pump in the computer mainframe room.
5. Replace the water damaged ceiling tile in the main frame room.
6. Consider placing plastic/rubber mats beneath water coolers.
7. If not in use, seal unused shower drain in the handicap restroom or pour water down regularly to prevent sewer gas back up.

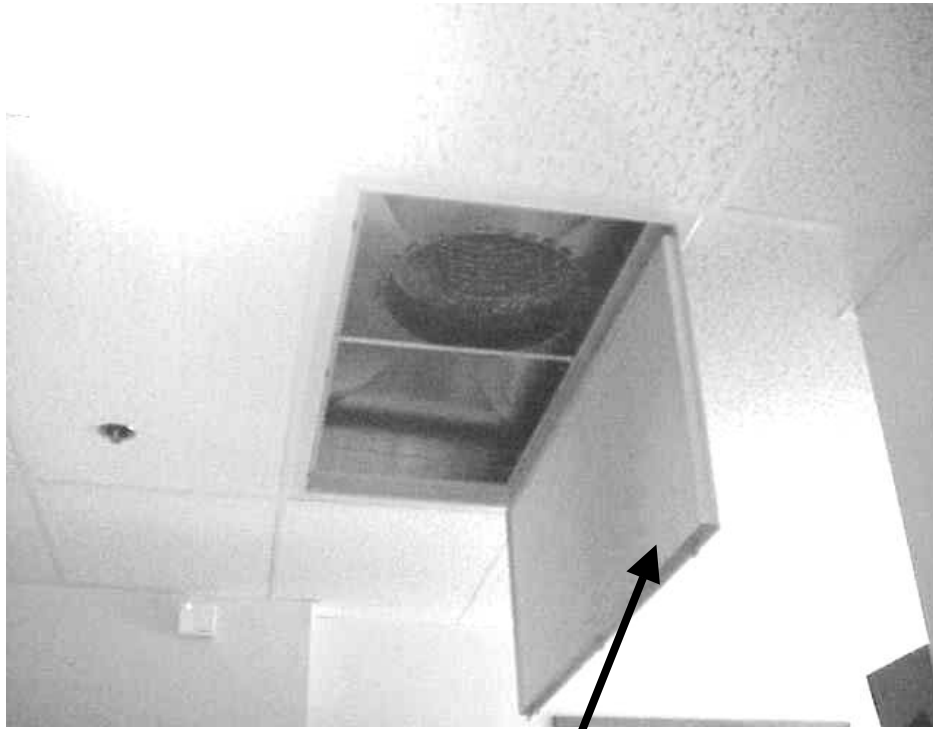
Picture 3

The design of the heat pumps does not allow for installation of filters within or on the unit. Filters for this system are installed within the return vent frame (see Picture 3). Two filters were installed within the return vent frame (see Picture 4) that did not fit flush with the rack. Filters should be one piece that fits flush with the filter rack. If two filters are to be used, the filter rack must have the appropriate equipment to make each filter fit flush in the rack. Air drawn into the return vent will bypass filters through spaces between filters and racks. This can result in dust, dirt and other debris being distributed by the ventilation system.

Return Vent with Filter Installations

1. Operate the rest room exhaust vent to prevent odors entering occupied areas.
Consider placing a timer to run the vent system during office hours.
2. Replace the filters in the return vents with one that fits flush within the filter frame. Consideration should be given to providing a higher efficiency air filter for the HVAC system in order to prevent odors and dusts from being entrained by the heat pumps.

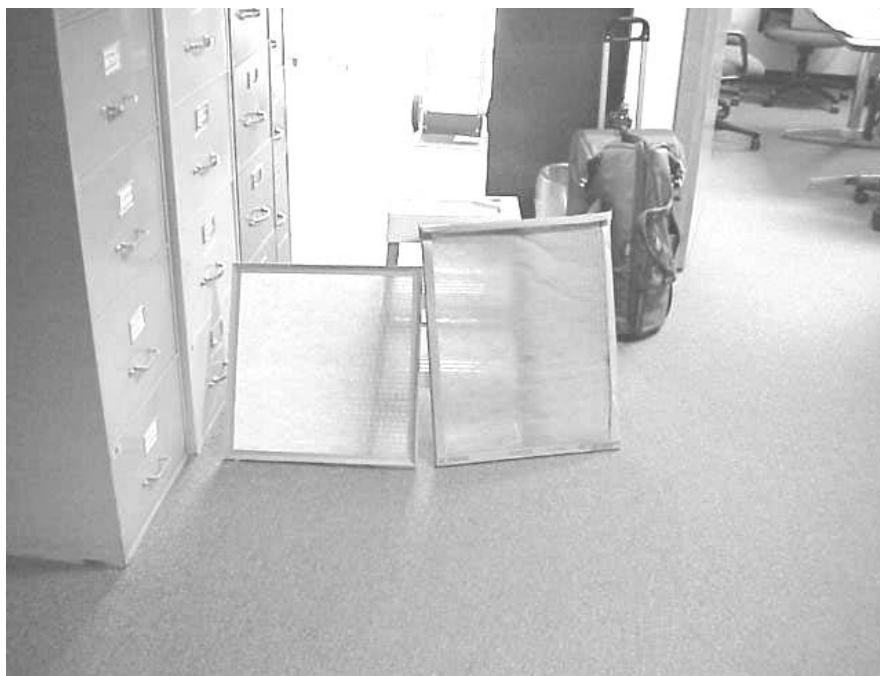
Picture 4

Two Filters Installed in Return Vent Rack, Note See-through Quality of Filter Media
